AERIAL PHOTOGRAPHIC ANALYSIS OF SELECTED HAZARDOUS WASTE STUDY SITES

New Mexico and Texas

EPA Region VI

TS-AMD-82110a
April 1983

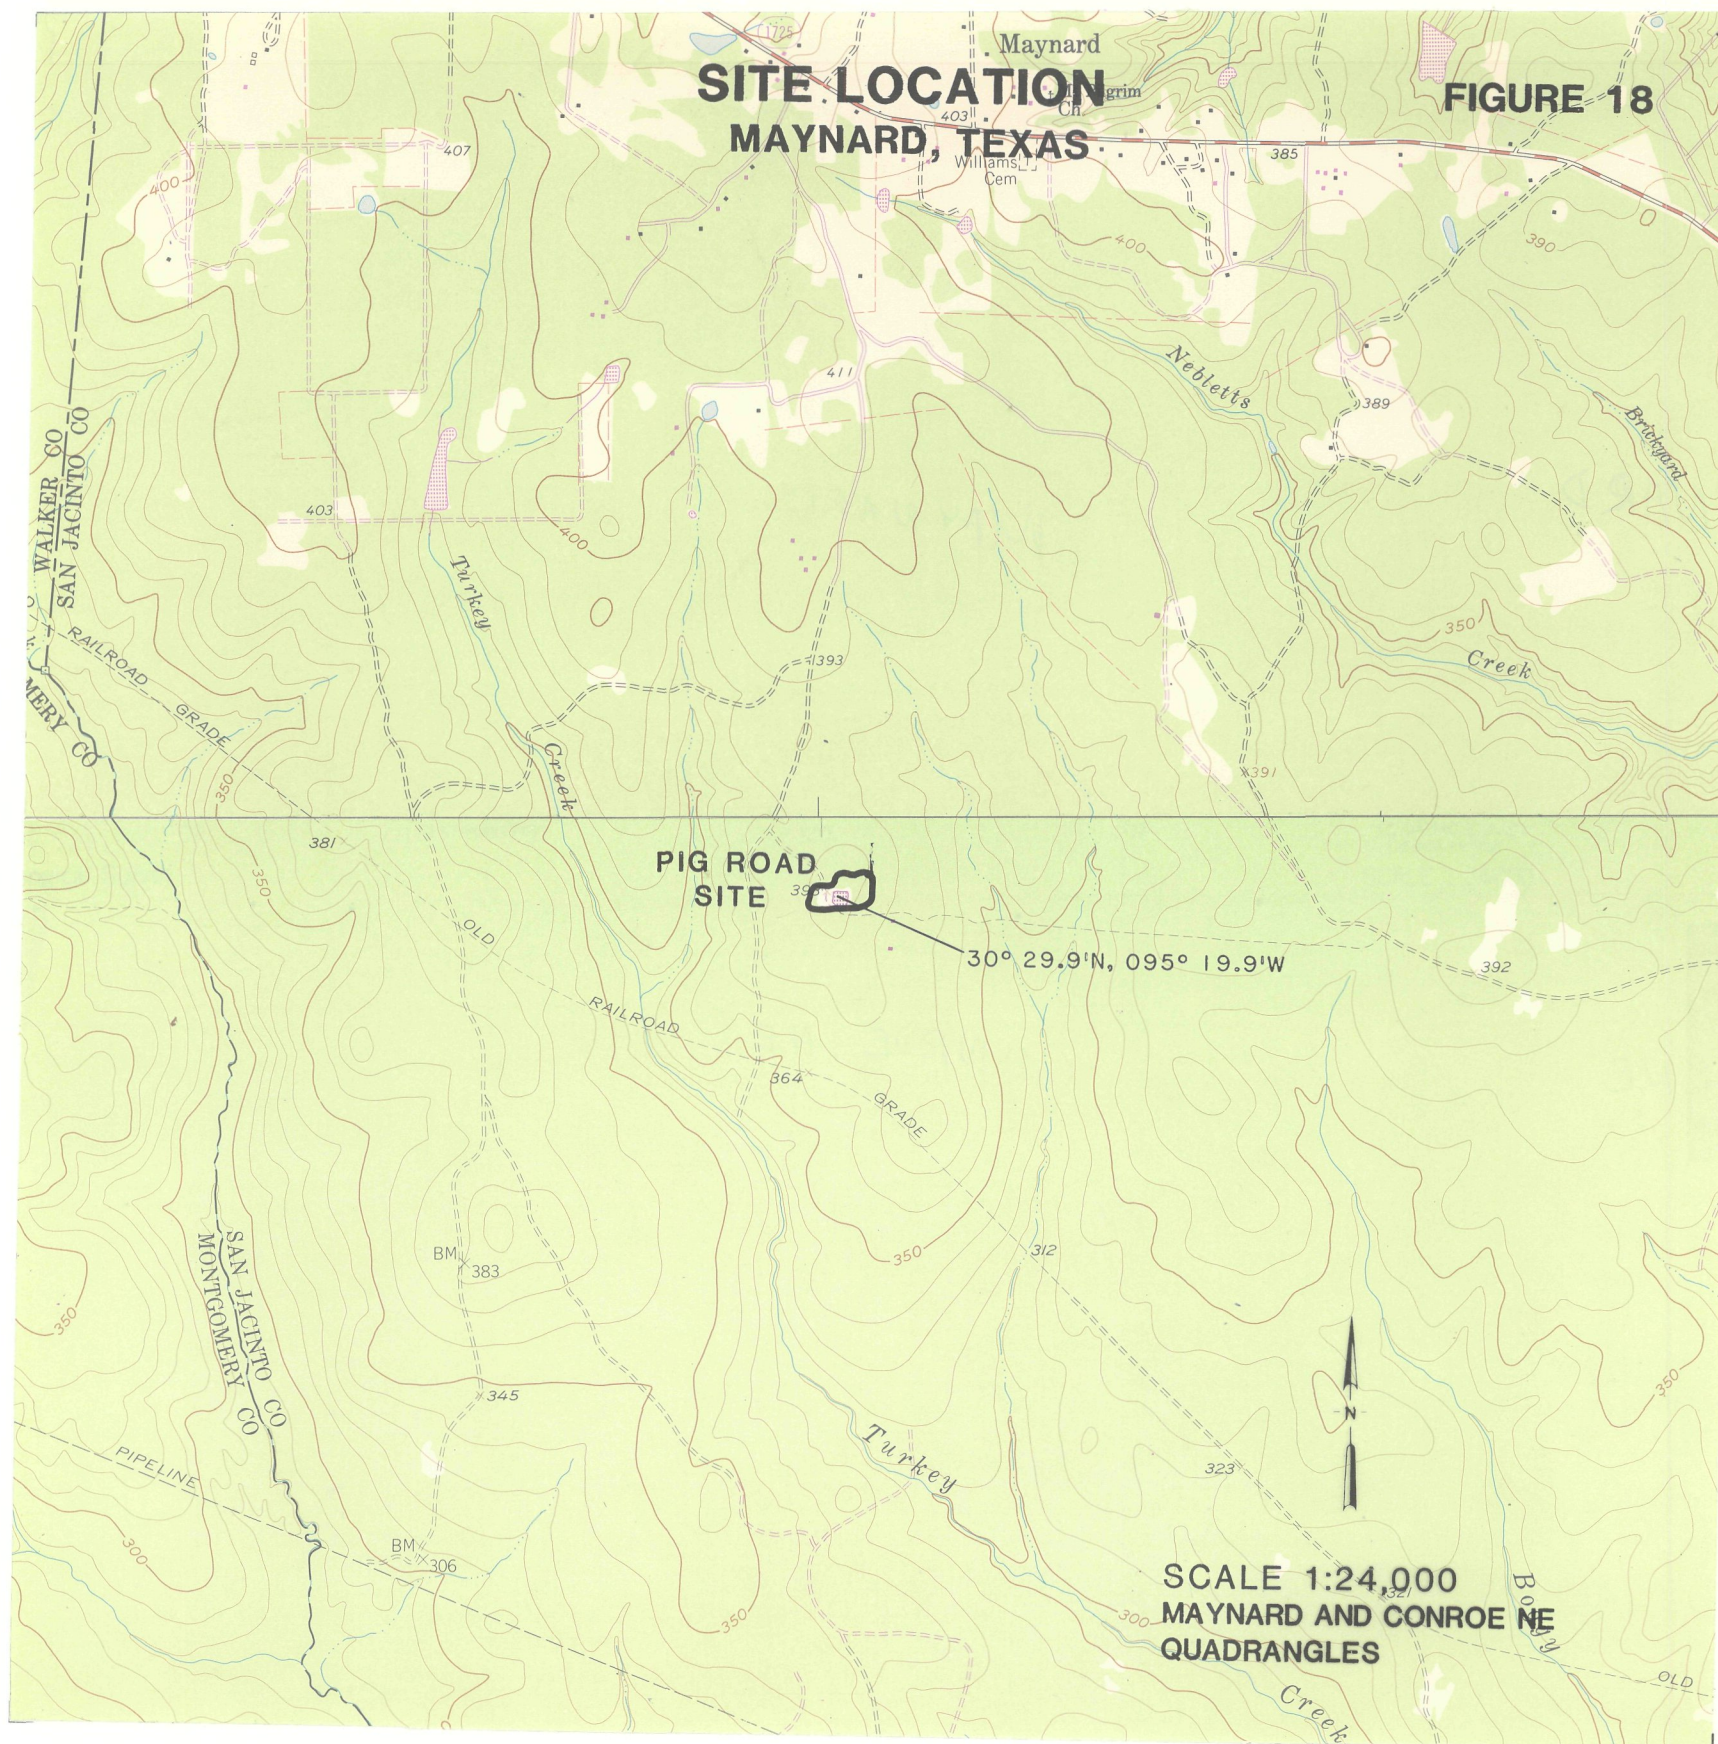
FIGURE 19

December 3, 1958, Photograph

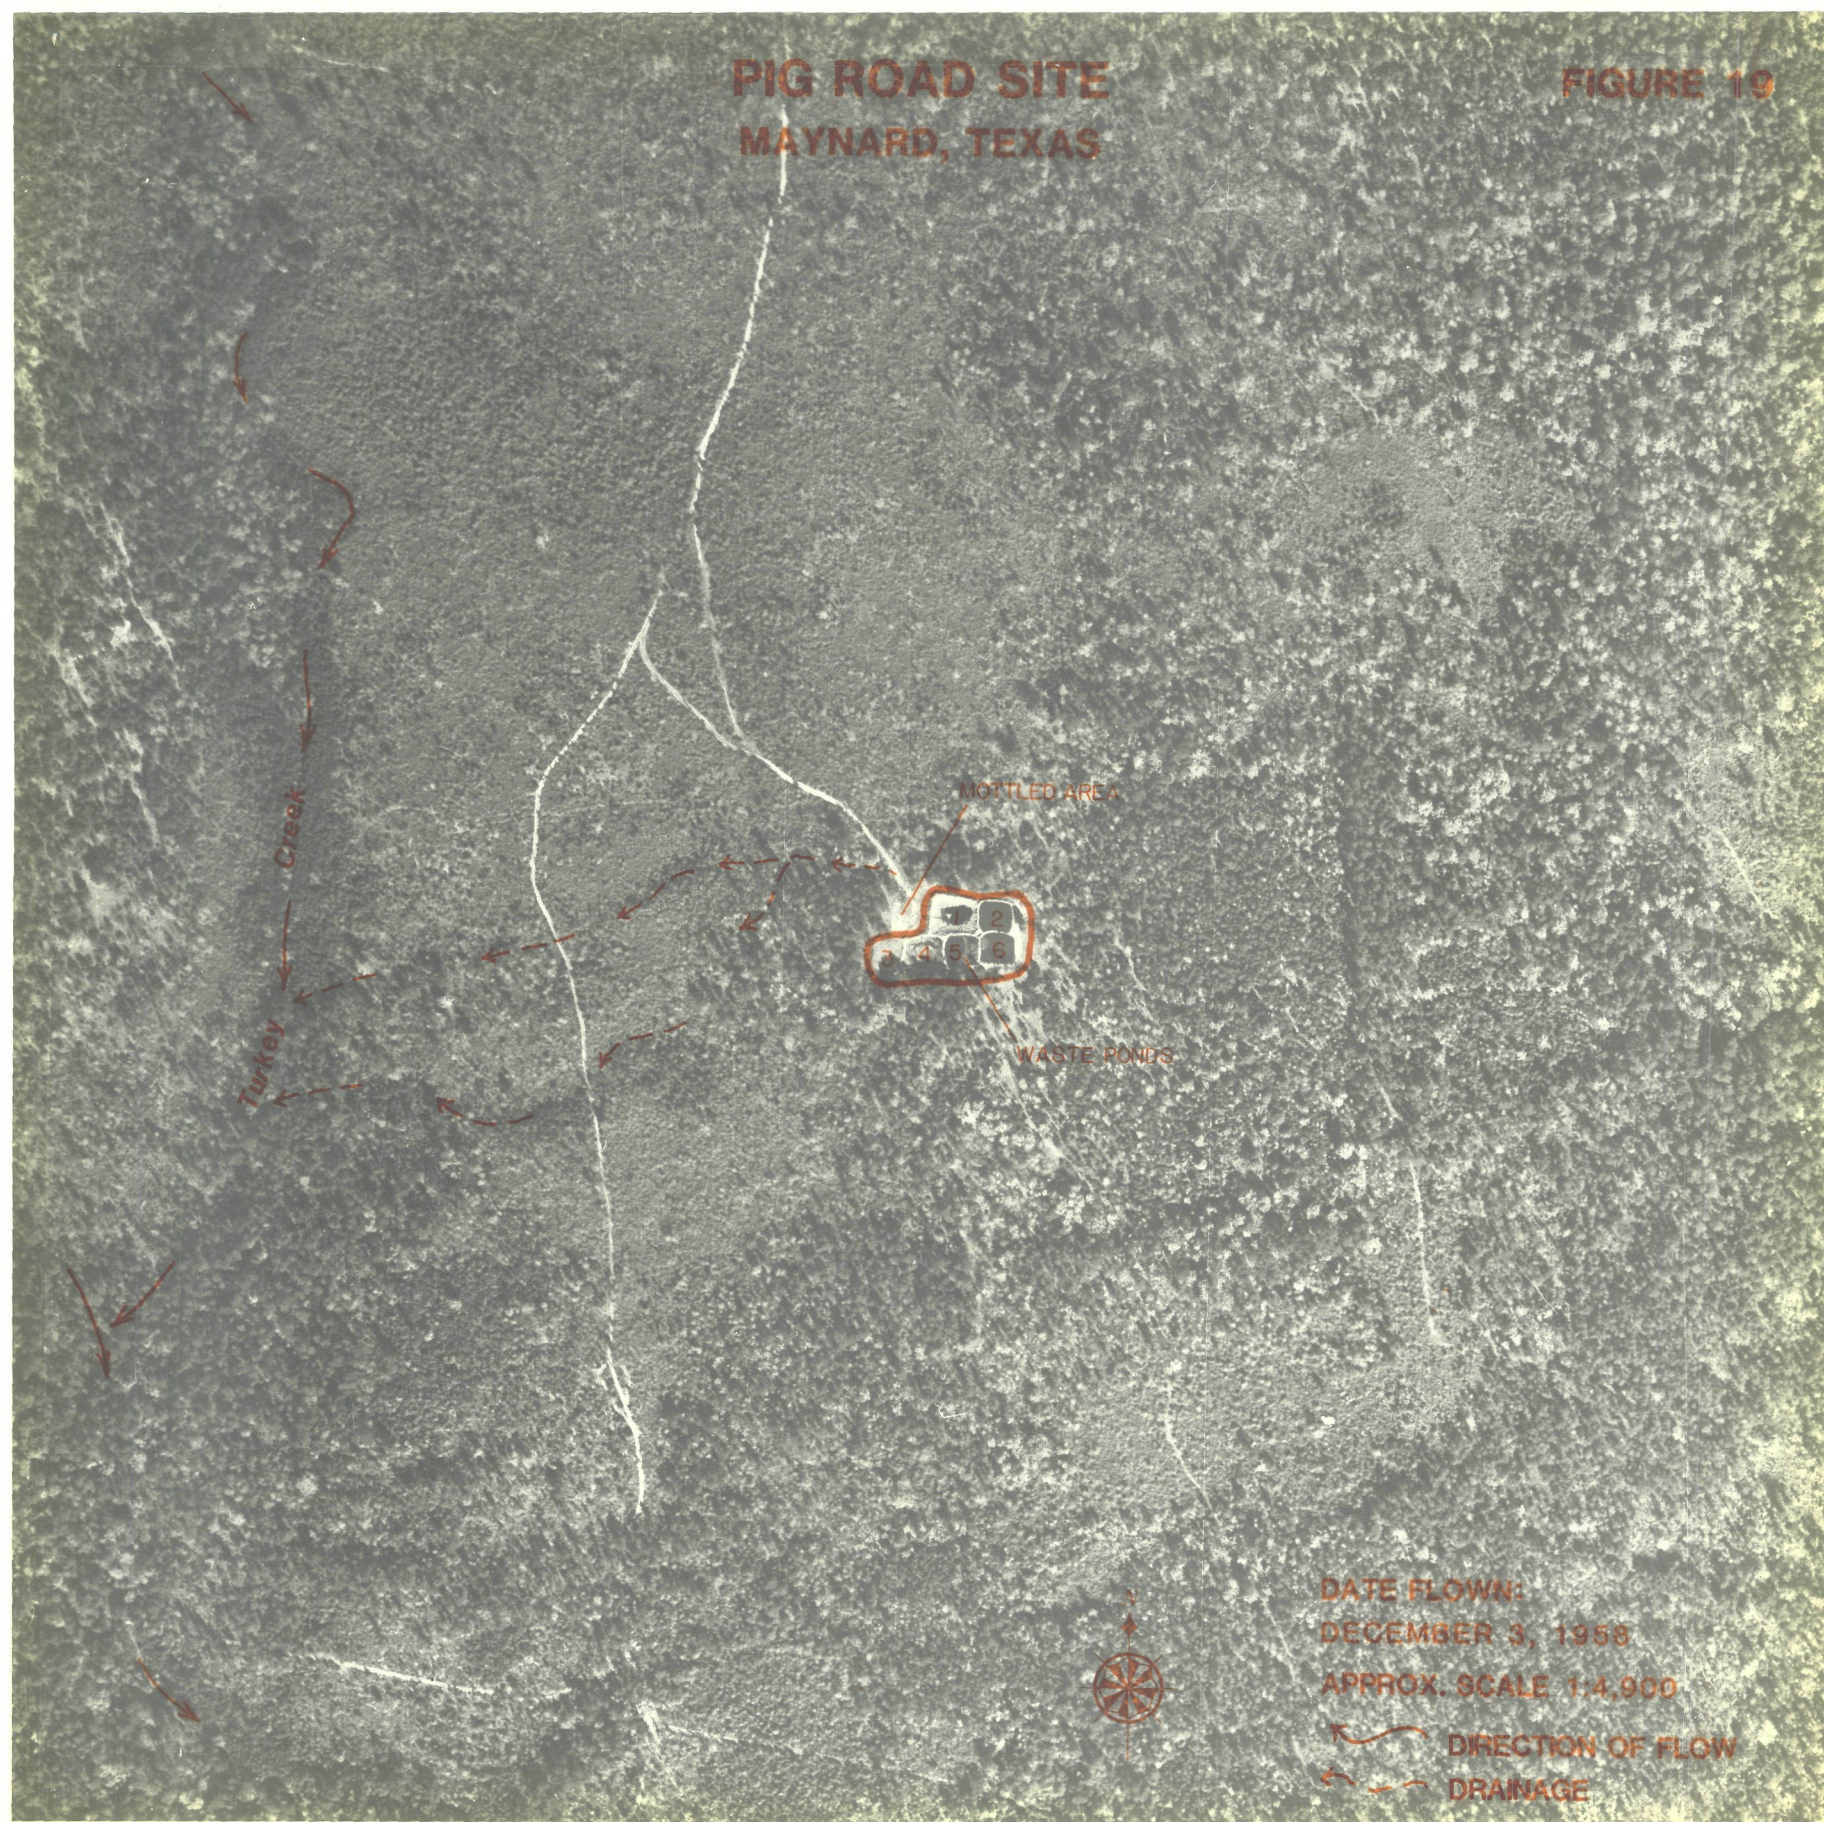
November 20, 1968, Photograph

All waste ponds that were present on the December 1958 photograph (Figure 19) remain visible. For the most part, the ponds appear to contain less liquid than they did on the 1958 photograph.

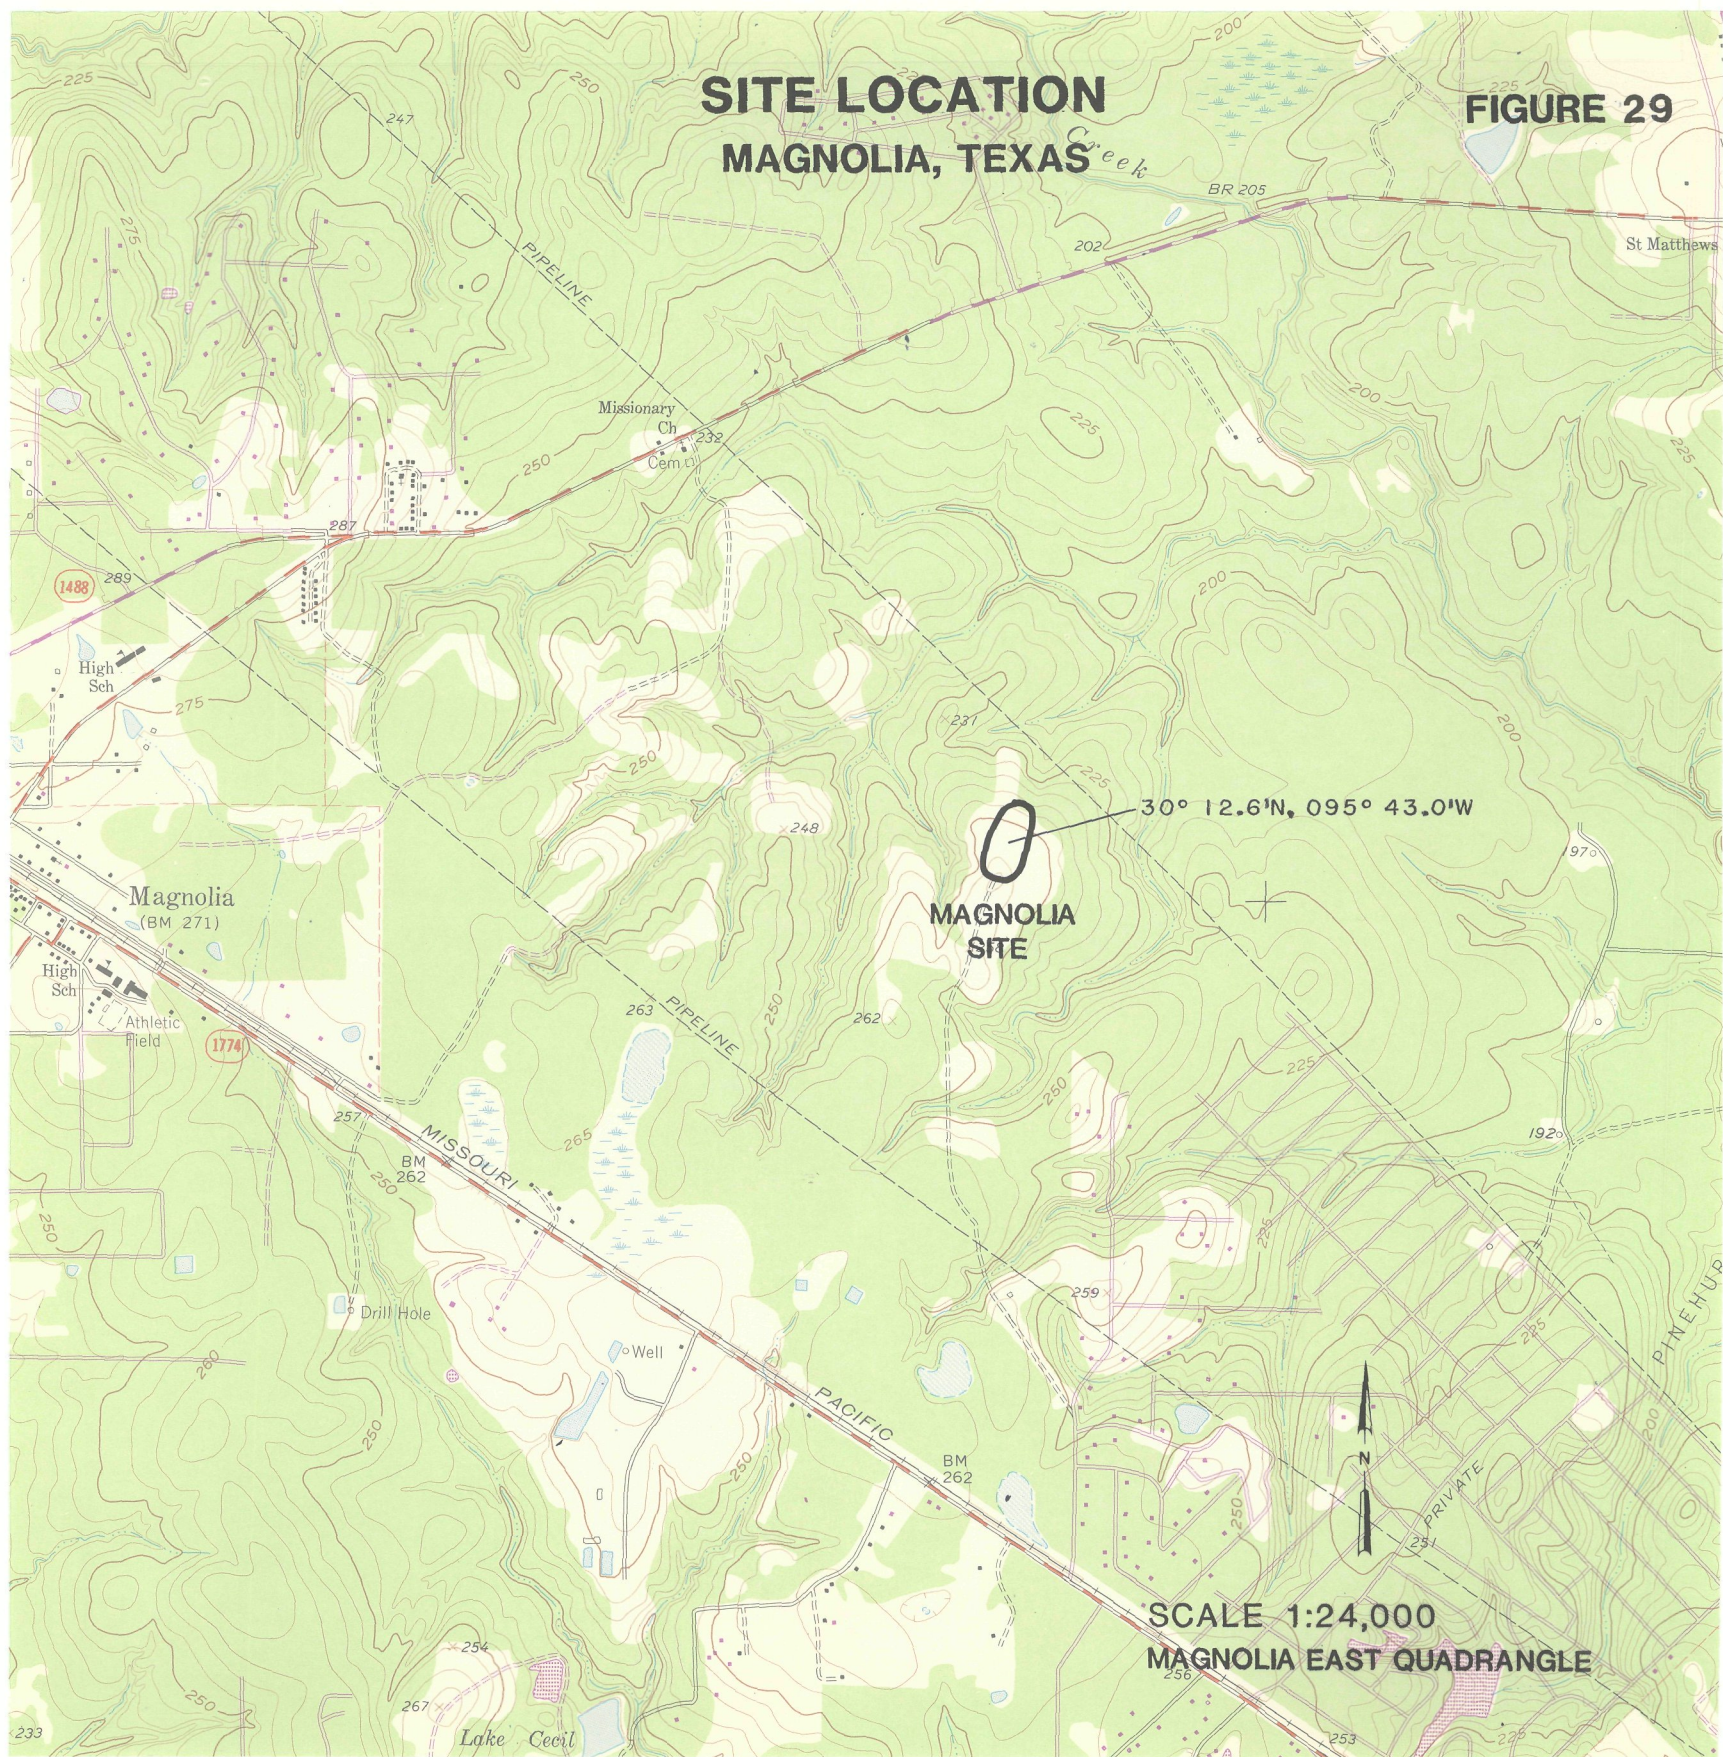
FIGURE 30

December 5, 1952, Photograph

A large clearing has been cut out of a heavily forested area (Figure 30). The area is serviced by an access road that leads northward from Farm-to-Market Road 1774. No evidence of waste disposal is noted on the photograph.

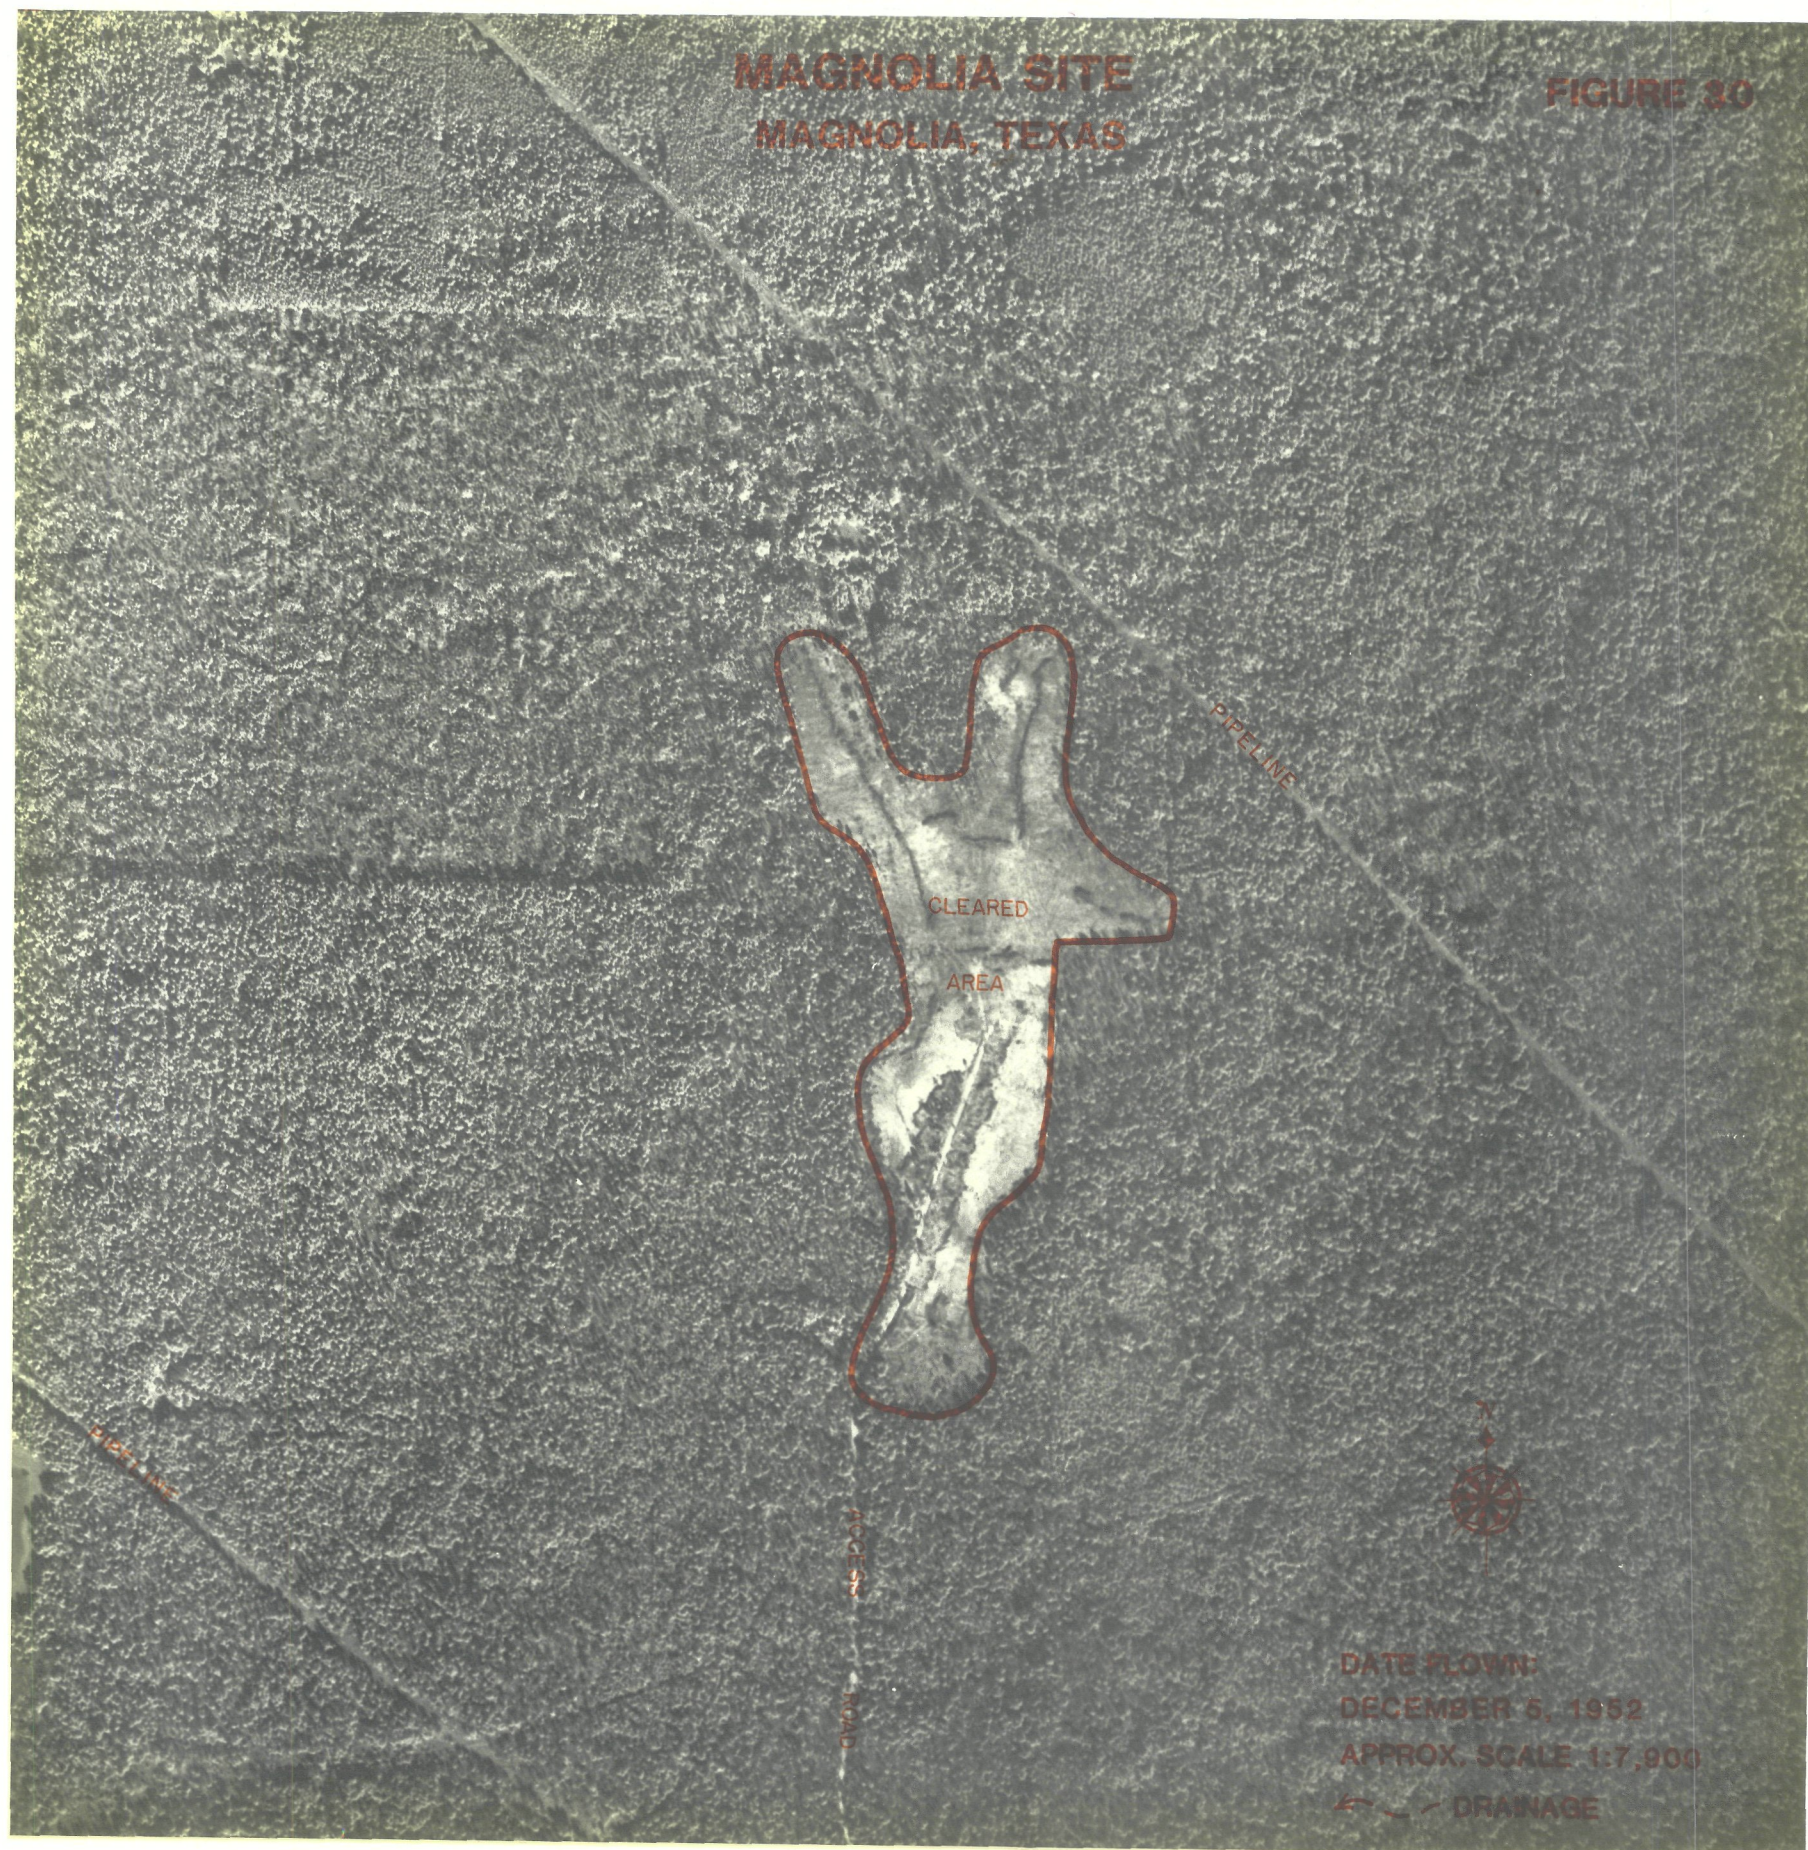
FIGURE 31

December 4, 1958, Photograph

A waste disposal area (Figure 31) is visible within a clearing that was previously noted on the 1952 photograph. A soil buildup that surrounds the disposal area has been breached in order to allow vehicular access to the site. Stains and fill material that are visible outside the built-up area suggest that waste materials may have flowed off the site.

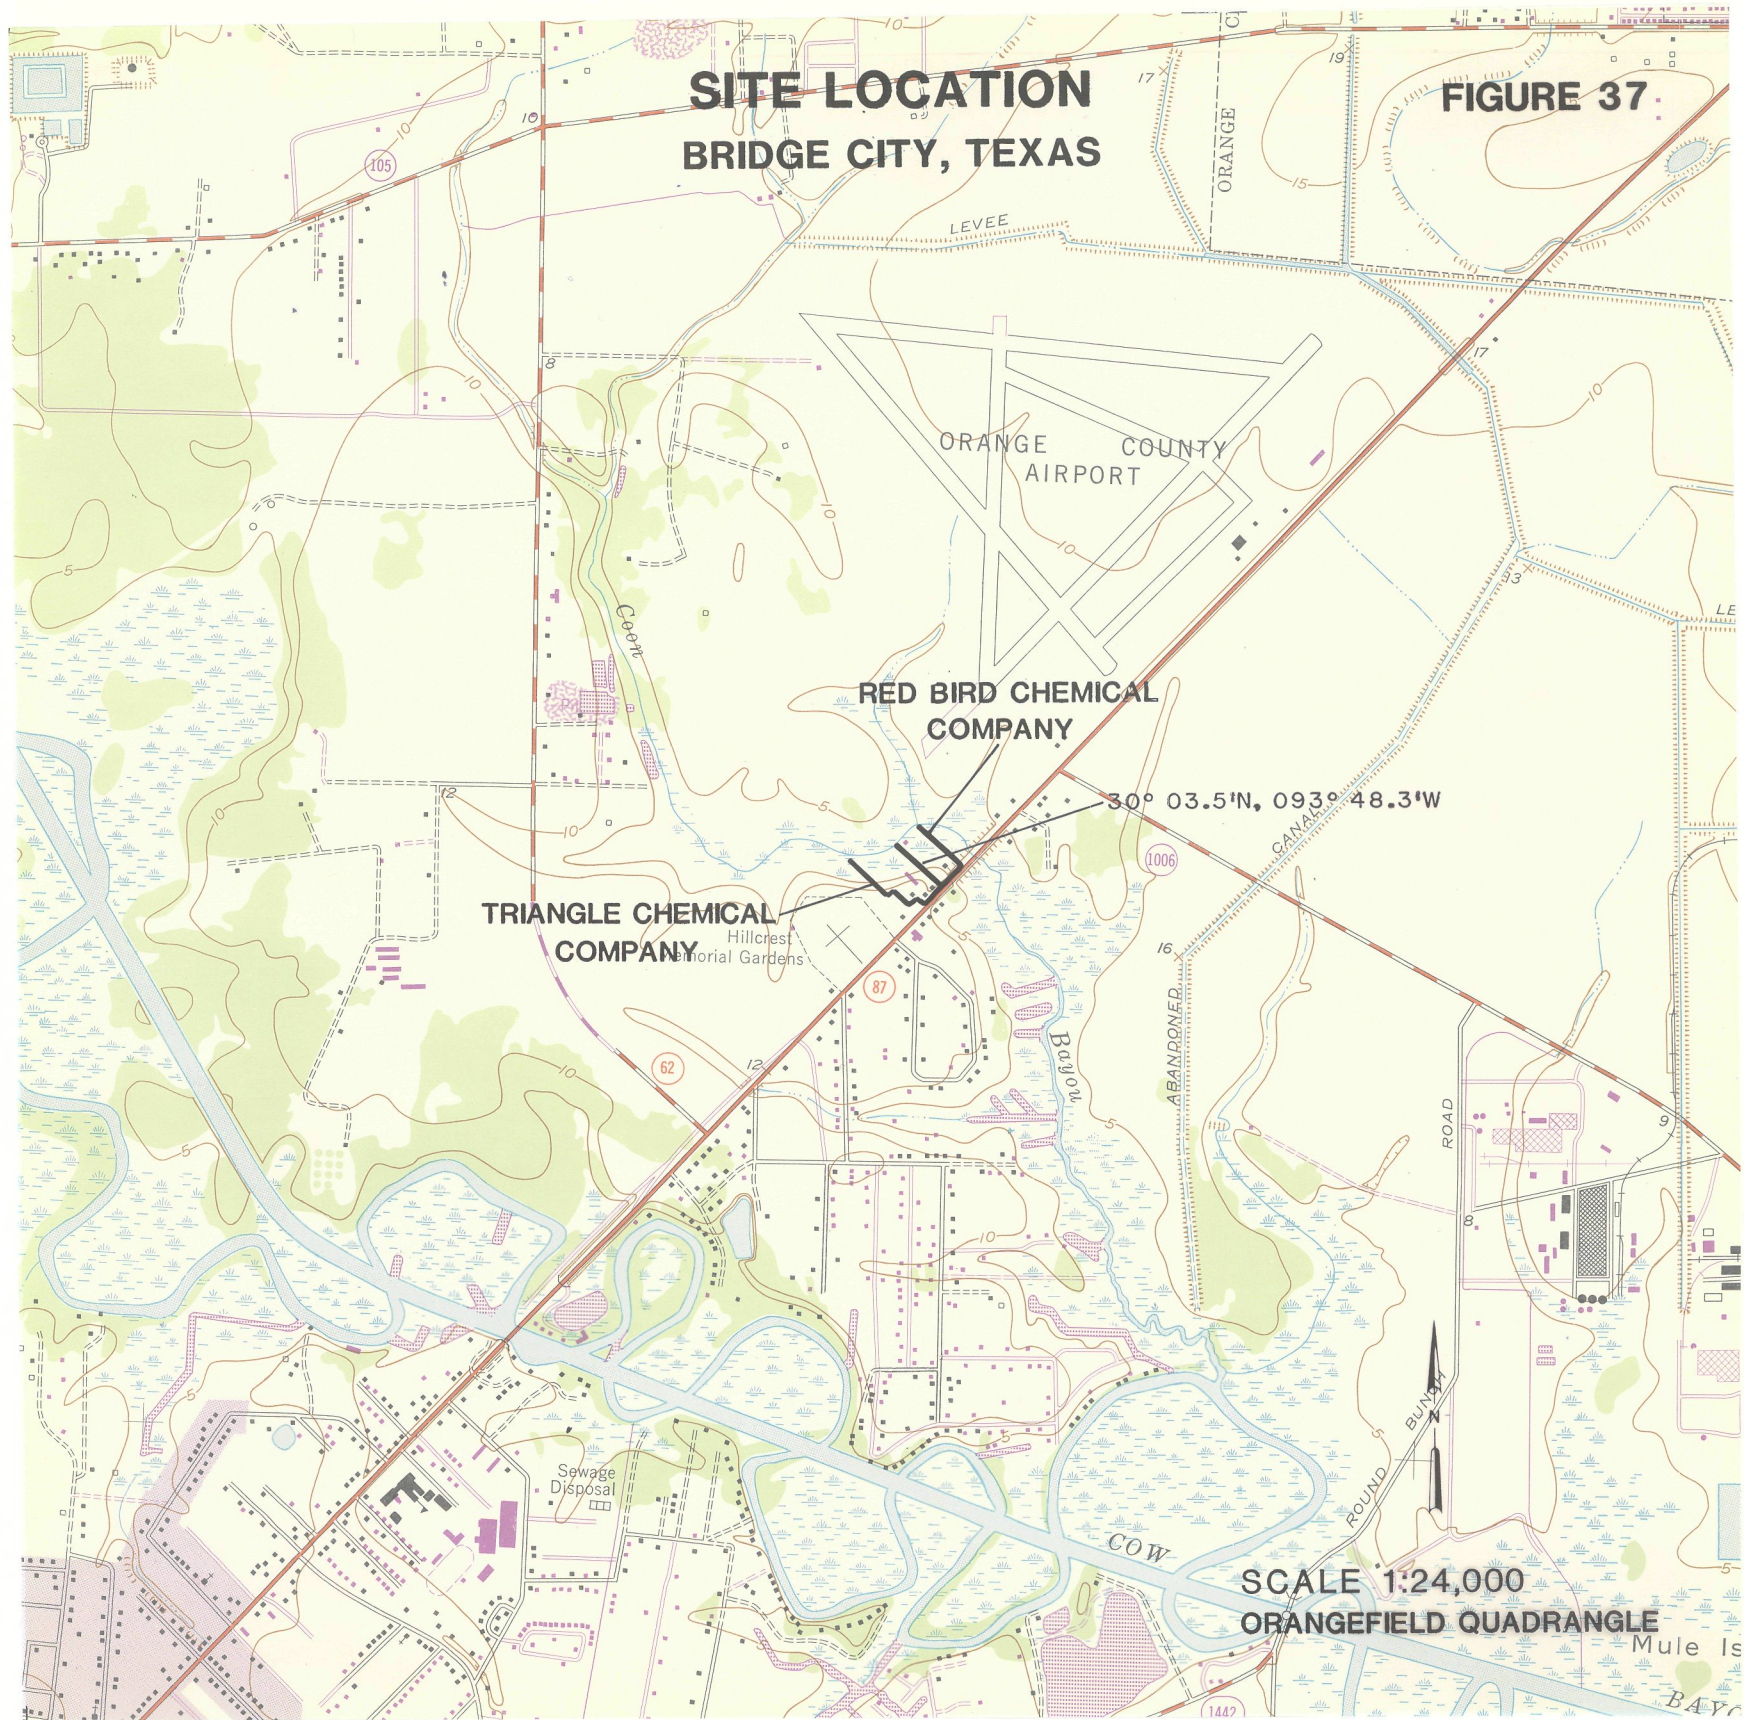
FIGURE 38

January 8, 1970, Photograph

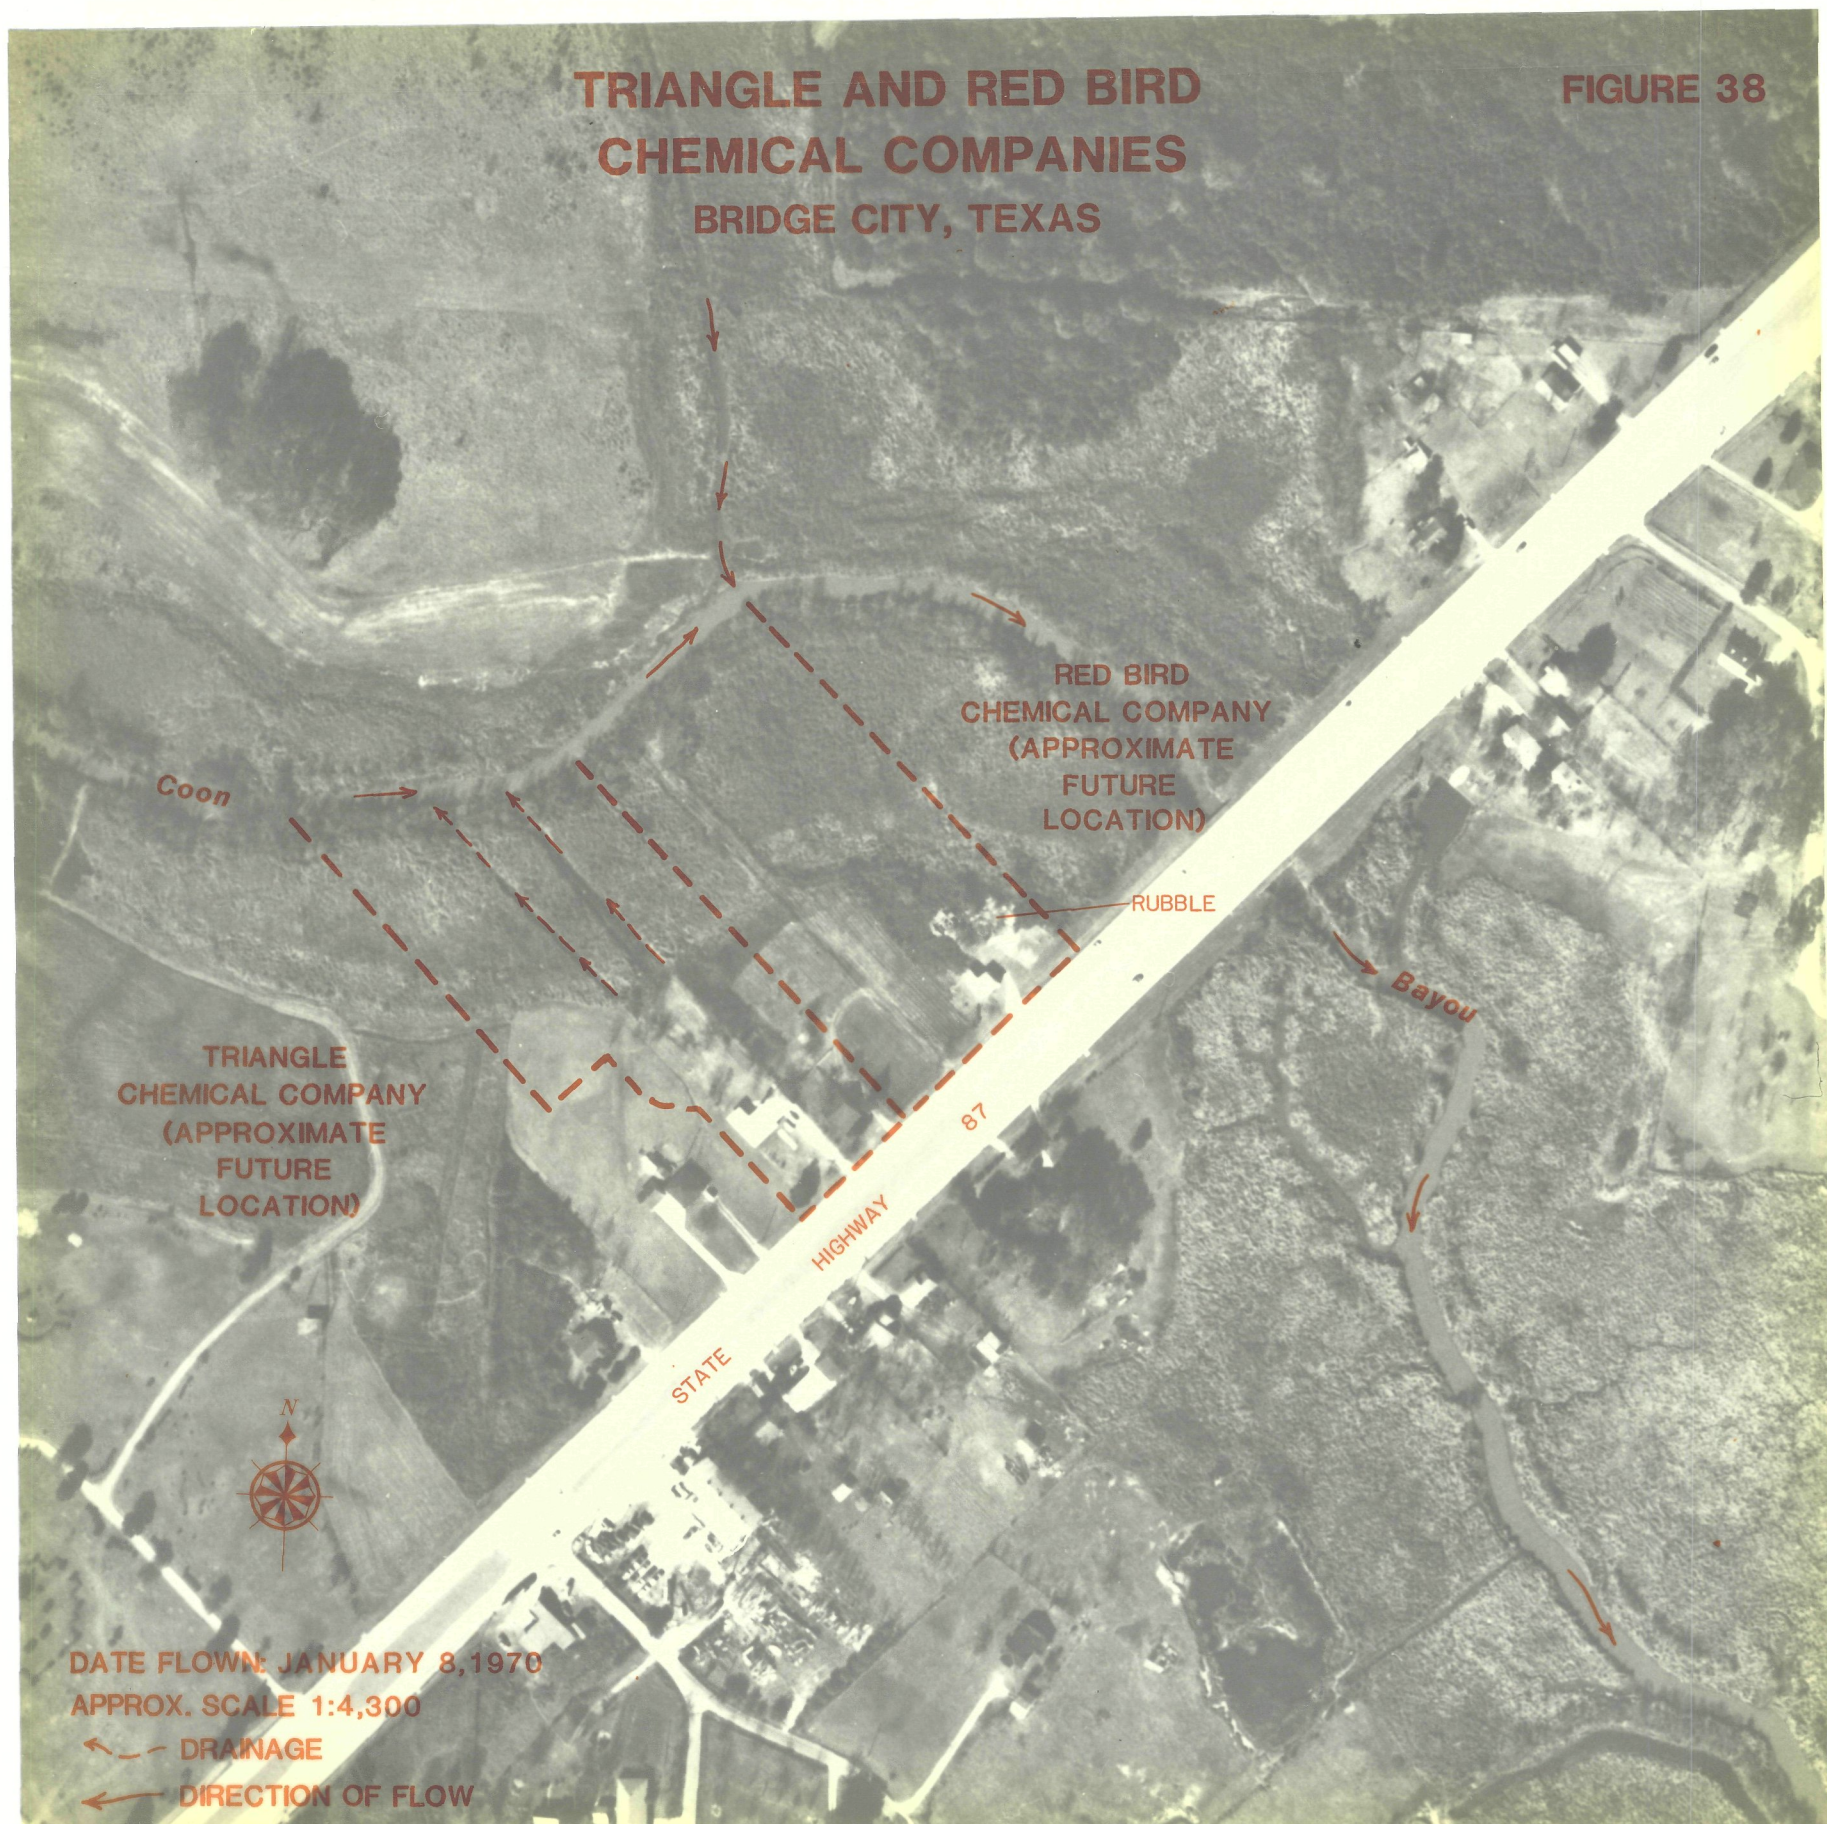
FIGURE 39

December 16, 1978, Photograph

Several structures have been constructed upon the Triangle and Red Bird Chemical Companies properties (Figure 39). Eleven vertical tanks which appear to be processing tanks are present at the Triangle Chemical Company facility. There are no containment devices surrounding the tanks.

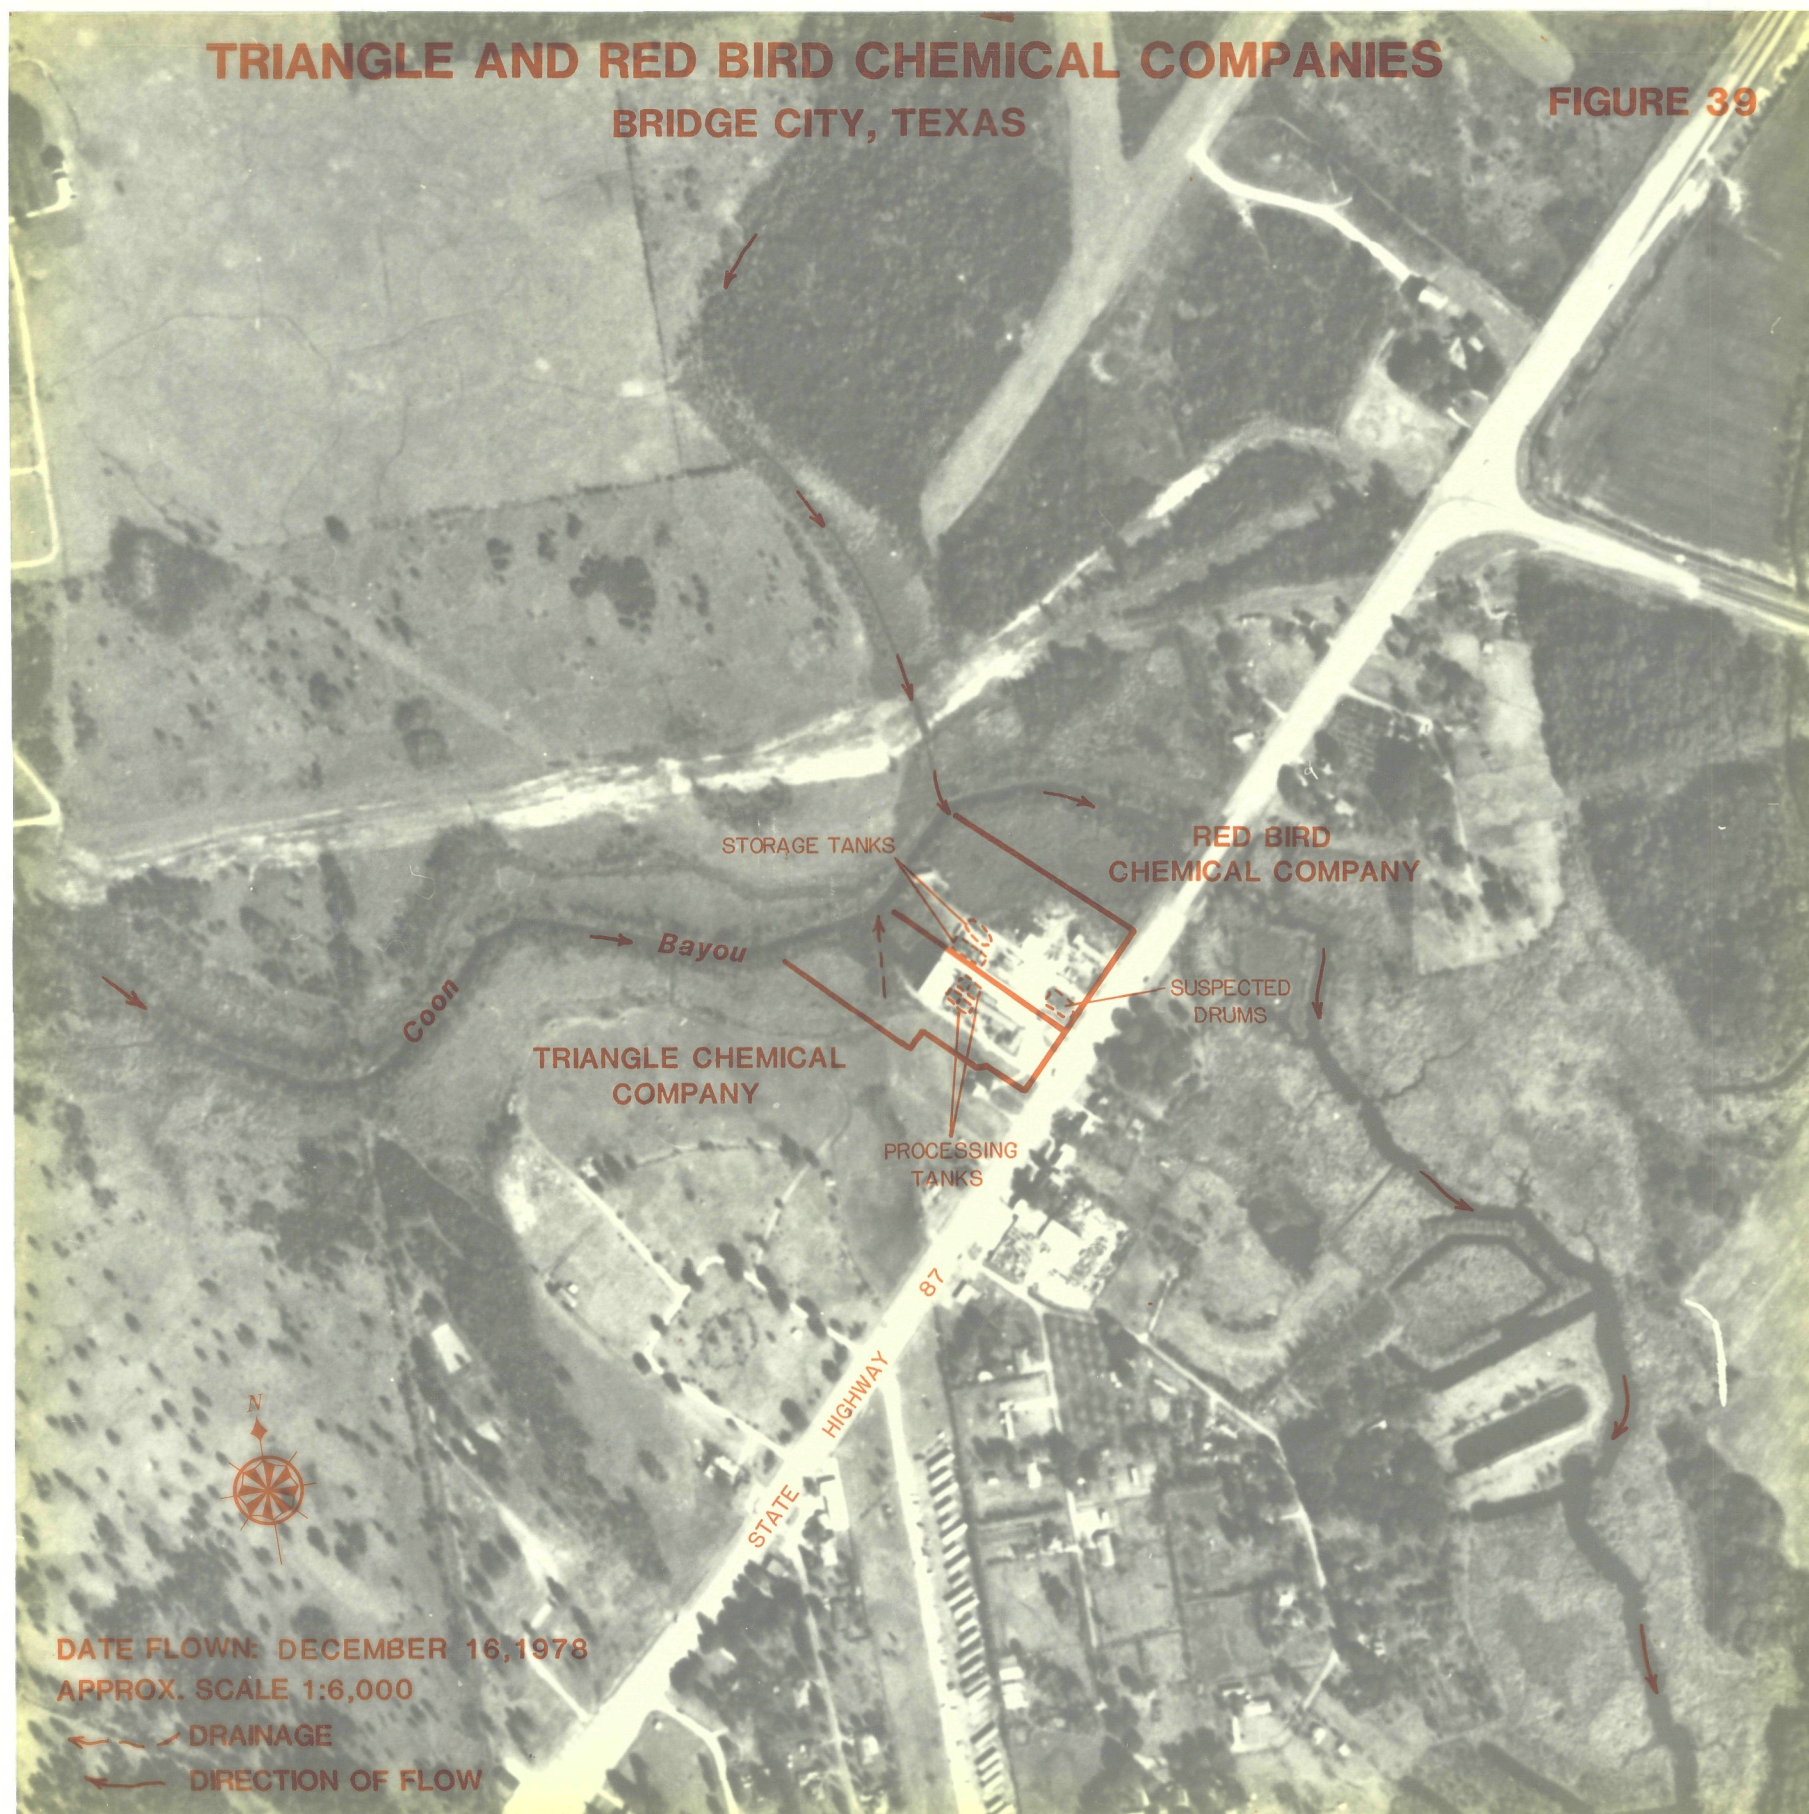
FIGURE 40

November 28, 1980, Photograph

The Triangle Chemical and Red Bird Chemical Companies (Figure 40) appear structurally similar to their appearance on the December 1978 photograph. The concentration of drums that was present on December 16, 1978 (Figure 39), has been removed from the Red Bird facility. A large stain is visible in the general area where the drums were formerly situated. Additional stains are noted elsewhere within the Red Bird facility. There is no indication that spillage has flowed off the site.
